NBS CIRCULAR 550

**Mechanical Failures
of Metals in Service**

For many years the National Bureau of Standards has made examinations of metal parts that have failed in service for evidence bearing on the causes of failure. Thirty-five such cases, representing the most frequently observed types of failures are described, and the factors of design, fabrication, or use contributing to these failures are presented. The characteristics by which the various types of fractures can be recognized are discussed, and recommended precautions that should be observed to reduce mechanical failures of metals in service are included.

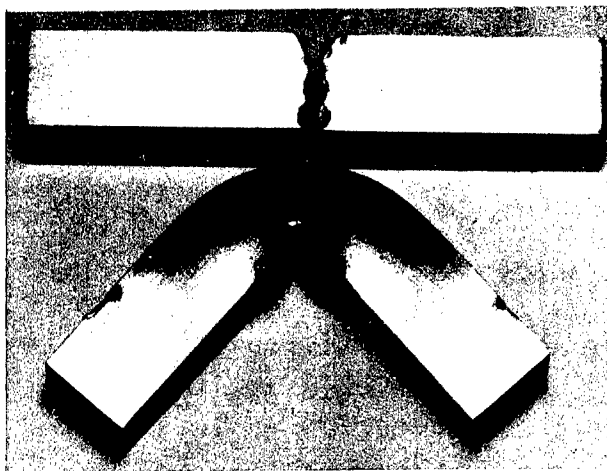
FIGURE 1. *Effect of geometry on the ductility of a steel specimen.*

Identical specimens with a notch in one side were loaded by supporting the ends and striking the middle with a heavy pendulum. The upper specimen was struck on the side opposite the notch; the lower one on the side containing the notch. $\times 2$.

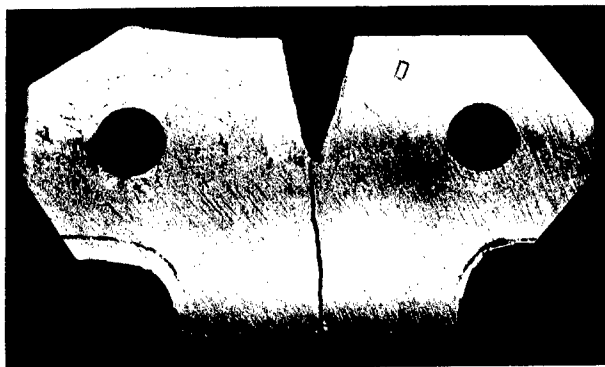
FIGURE 2. *Notched specimen broken in tensile test in the laboratory.*

Holes were used to apply the load in line with the bottom of the notch. $\times 1$.

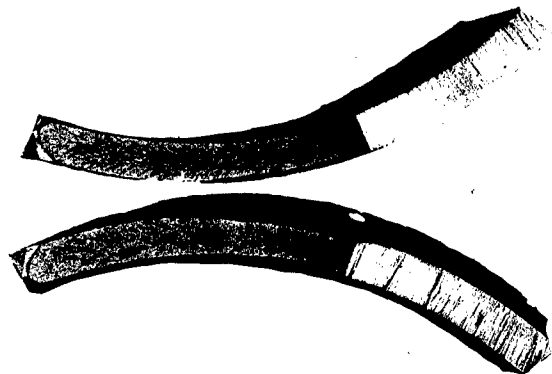
FIGURE 3. *Fractured surfaces of specimen shown in figure 2.*

The specimen broke by tearing from the root of the saw-cut notch, and it will be noted that the "chevron" markings point toward the source of the fracture. $\times 1\frac{1}{2}$.

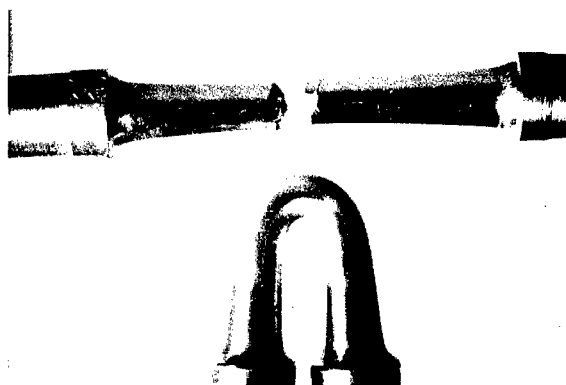
FIGURE 4. *Effect of repeated stress on ductility.*

Identical specimens were loaded by bending. The upper one was subjected to many cycles of reversed loading, and failed with a typical fatigue fracture, showing no ductility. A single high load was applied to the lower specimen, which bent without breaking. $\times 2$.

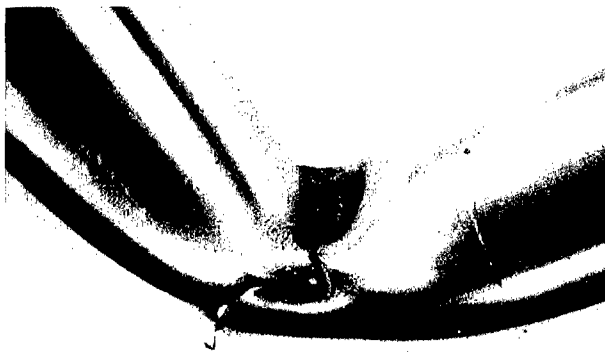
FIGURE 2.1. *Fractured piston parts fitted together in approximately the position they had occupied at the time of final fracture.*

The extensive plastic deformation that had occurred prior to fracture is evident. $\times 1$.

Case 2: Landing-gear retracting-strut piston (steel, chrome-plated). History of material was not available, but it is thought that this fracture was not a primary failure. This example is included to illustrate the characteristics of fractures due to overload. The tubular part, originally straight, had bent through approximately 75° before final fracture occurred. The extent of the plastic deformation can be seen by the checks in the chromium plate.

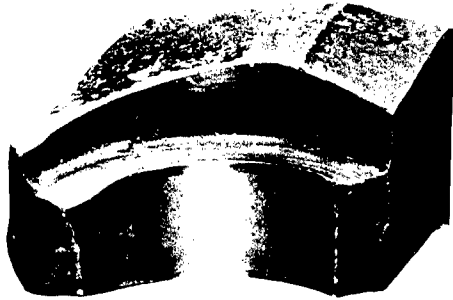
Case 8: Wing hinge fitting (SAE 4340 steel). The extremely coarse grains visible on the fracture surface on one side of the lug, and the intergranular oxidation in this area was apparently caused by severe local overheating after forging but before heat treating. The resultant structure had so little intergranular strength that it fractured under normal service loads.

FIGURE 8.1. *Fractured lug showing a brittle fracture on the right and a normal ductile fracture on the left. $\times 1$.*

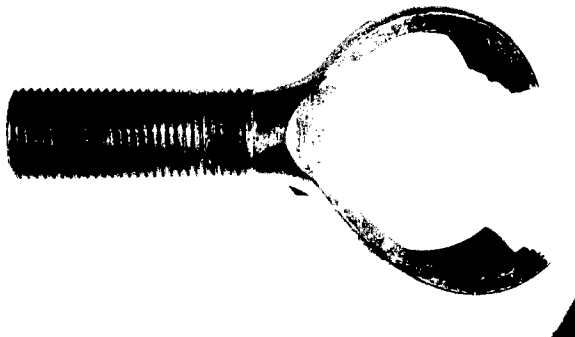
Case 11: Rod end bearing from the wing strut of a light plane (free-machining steel). Fracture of part during apparently normal flight caused a crash. The numerous large inclusions in this material greatly reduce its ductility transverse to the rolling direction. The fitting was cut from bar stock, so that the inclusions were parallel to the length of the shank. Thus the tensile stress at the top of the eye was applied in a transverse direction, and the strength of the thin section was inadequate to support normal flight loads. In order to avoid loading in a transverse direction in a part of this kind, it is generally necessary to use a properly designed forging. The free-machining steels are unsuitable for critical parts subject to high stress in service because of poor transverse properties and great variability.

FIGURE 11.1. Rod end bearing which fractured in service. The fracture showed almost no local ductility. $\times 1$.

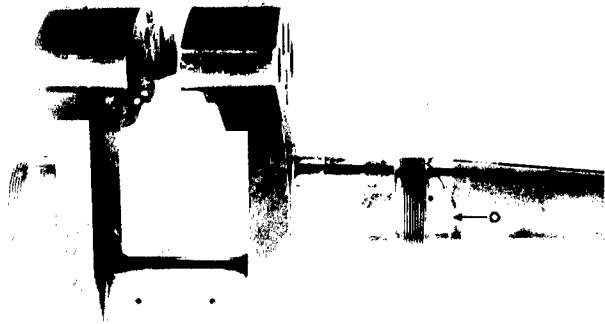
Case 15: Aircraft engine crankshaft (alloy steel). The crankshaft fractured after a total of 220 hours of service. The fatigue crack originated in an area where fretting had occurred under the propeller hub. Fretting is the term given to the action that results in surface damage when there is relative motion between solid surfaces in contact under pressure. The action may be produced by extremely small motions and causes a severely pitted condition of the surface. In this case the pits concentrated the stress to such an extent that the peak stress was greater than the fatigue strength² of the steel.

FIGURE 15.1. *Crankshaft with broken parts fitted together.*

The fracture originated at arrow "o" in an area where rubbing had occurred. $\times \frac{1}{4}$.

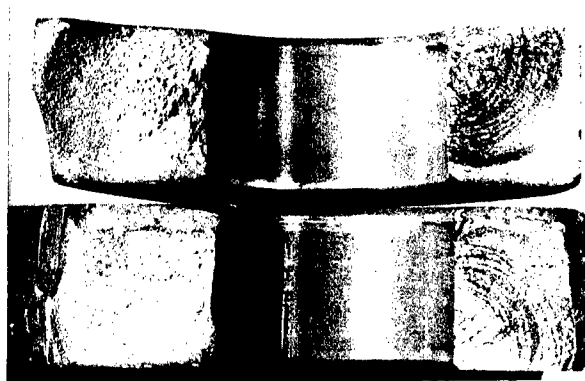
FIGURE 18.2. Lower lug of Fig. 18.1 showing the origin of the fatigue fracture (arrow) on the inside of the hole at the point where the inserted bushing ended.

The surface of the fatigue fracture appears rough at this magnification, but it was actually made up of numerous facets, giving it an appearance similar to the fracture in a brittle substance like coal. The contrast between this fracture and a similar one in a steel forging is apparent when this figure is compared with figure 22.2, which is at the same magnification. The concentric rings were caused by variations in the rate of progress of the crack due to changes in stress. The left side of the lug failed due to overload after the right side had broken. $\times 1$.

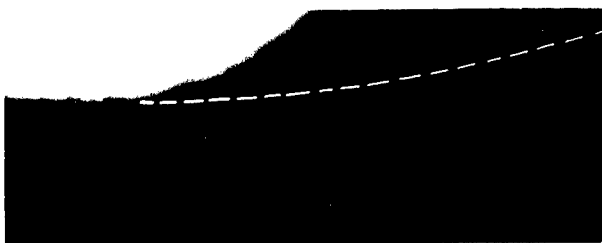
FIGURE 20.2. *Profile of the fillet adjacent to the small diameter (left).*

The dashed arc shows for comparison how a $\frac{1}{2}$ -inch radius fillet would appear at this magnification. $\times 17$.

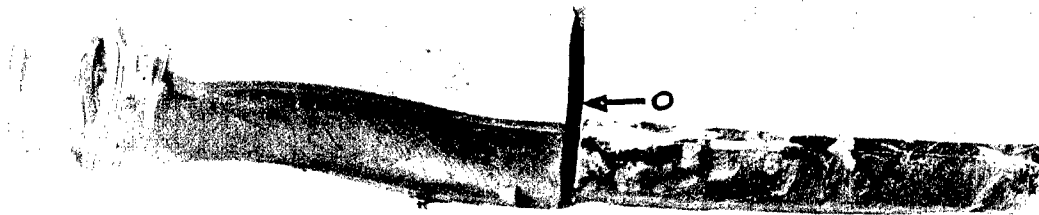
Case 23: Aircraft propeller blade (steel). The hollow blade failed due to a fatigue crack that originated at one of several defects on the inside of the blade. These defects, which occurred prior to heat treatment and painting of the blade, appeared to have resulted from a gouging, or galling, action, probably due to scraping against a mandrel.

FIGURE 23.1 *Flat side of the broken propeller blade.*
The fatigue crack started on the inside surface near arrow O.

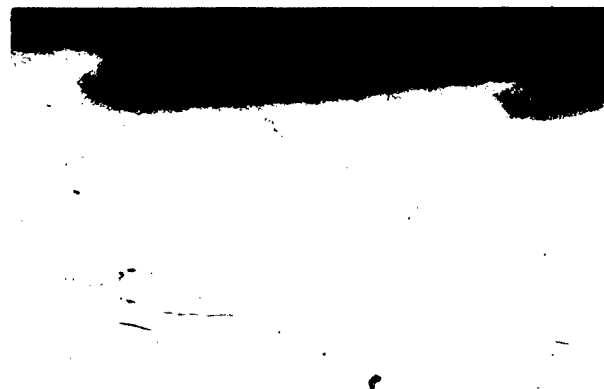
FIGURE 23.4. *Longitudinal section through the defect shown in figure 23.3.*

The serrations were caused by the galling action of another surface being dragged across this one. The action is analogous to the chattering of a machine tool against the work. Etched with nitric acid in alcohol. $\times 100$.

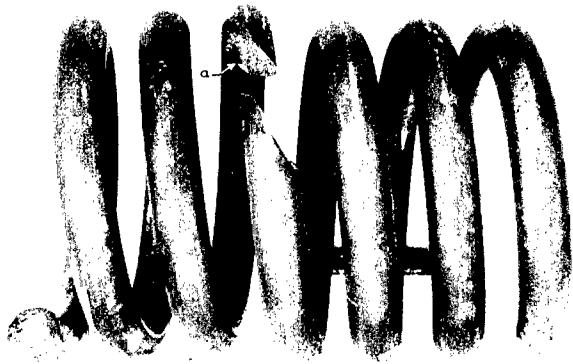
torsional stress. In the absence of stress raisers, the first cracking in torsion usually occurs in planes of maximum shearing stress, which are parallel and perpendicular to the length of the rod. Because of the directional properties of the rod from which the spring was wound, the resistance to fatigue was less in the parallel direction than the perpendicular, so the crack developed as shown in figure 25.3. When this crack had progressed to a considerable extent, it caused sufficient stress concentration to initiate a crack due to tensile stress in a direction approximately 45° to the length of the rod. This second crack progressed only a short distance before the rest of the section failed due to overload.

FIGURE 25.1. *Fractured helical spring showing the origin of the diagonal fracture on the inside of the coil at arrow "a".* $\times \frac{1}{2}$.

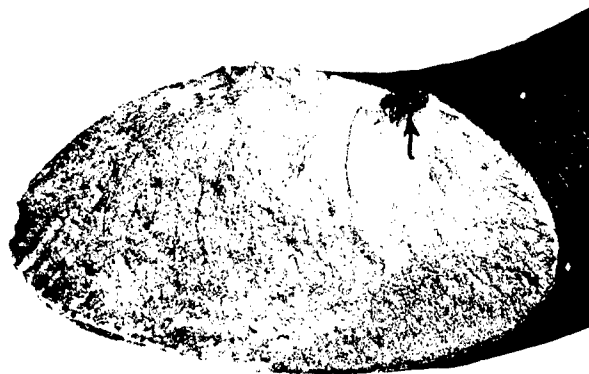
FIGURE 25.2. *Fracture surface on one part of the spring.*
The small dark area (arrow) is the tension fatigue crack which originated at the longitudinal (shear) crack. $\times 3$.

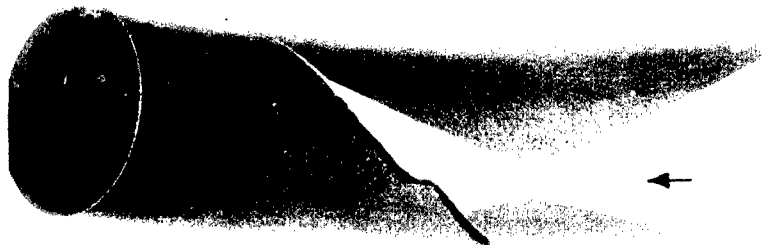
FIGURE 25.3. *The two parts of the fracture fitted together.*

The piece on the right has been ground to show the extent of the longitudinal crack (arrow) away from the fracture. $\times 2$.

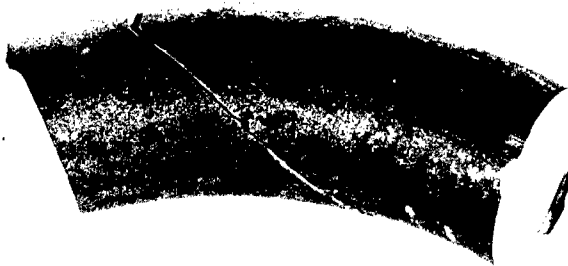
FIGURE 26.1. *Fractured pieces of spring fitted together to show surface pit at nucleus of fatigue fracture, arrow O.* $\times 2$.

Case 26: Helical spring (steel). In contrast to case 25, the fatigue fracture in this spring started on a plane normal to the tensile stress. The surface of the spring was somewhat pitted, and the stress concentration at one of these pits was sufficient to cause the initiation of the fatigue crack. The fatigue crack progressed over nearly half of the cross section of the rod before final fracture

occurred, indicating that the applied stress was relatively low and showing the severe decrease in fatigue strength caused by a surface defect.

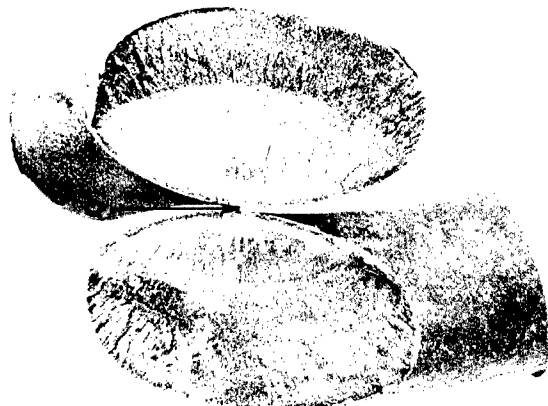
FIGURE 26.2. *Surfaces of the fracture; the fatigue crack progressed from the origin at arrow O across nearly half of the section before overload fracture occurred.* $\times 2$.

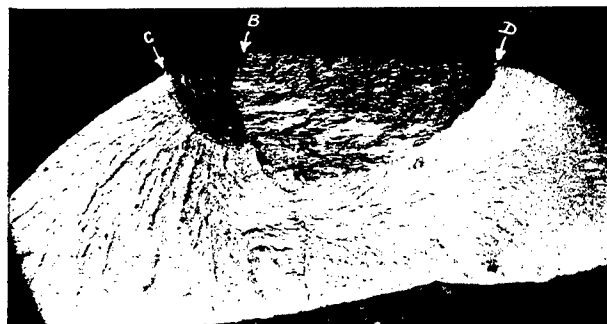
FIGURE 27.2. *Surface of the fracture.*

The dark fatigue crack areas at the top are easily distinguished from the lighter overload portion. The tensile fatigue crack from B to C is on a plane making an angle of approximately 45° to the plane of the paper. $\times 1$.

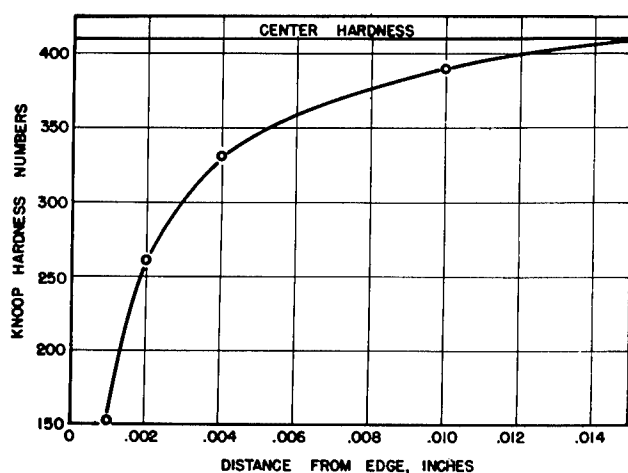
FIGURE 29.3. Results of microhardness measurements made on a cross section of the tube.

The hardness at the center corresponds to a tensile strength of approximately 170,000 lb/in.², whereas that nearest the edge indicates material having a strength of not more than 70,000 lb/in.²

Case 29: Lower flange of tubular wing spar (steel). This plane was used in mail pickup service. It crashed due to the fatigue fracture of the lower flange of the wing spar. The type of service in which this plane was used caused higher fluctuating loads on the wings than would be expected in normal service. In addition, the decarburized condition of the tubing greatly reduced its resistance to fatigue, as fatigue cracks almost invariably start at the surface. Laboratory tests (see Trans. Am. Soc. Metals, vol. 39, p. 45, 1947) on homogeneous and decarburized specimens indicate that the fatigue strength of the fractured tube would be approximately half that of material that had not been decarburized.

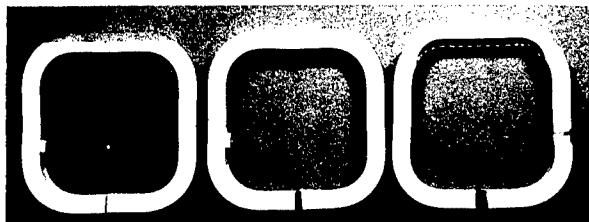
FIGURE 32.6. Three sections cut from one of the tubes to show the presence of internal stress.

In the section on the left the outside half of the wall thickness was first milled off, then the wall was sawed on the opposite side. No change in the width of the saw cut was observed. Tube expanded on being cut when no milling had been done, (center) and expanded still more when the inner half of the wall was removed prior to sawing (right). This indicates that there was a tangential tensile stress in the outer half of the tubes and accounts for the failure of the cracks to penetrate completely through the walls (fig. 32.3). $\times \frac{1}{4}$.

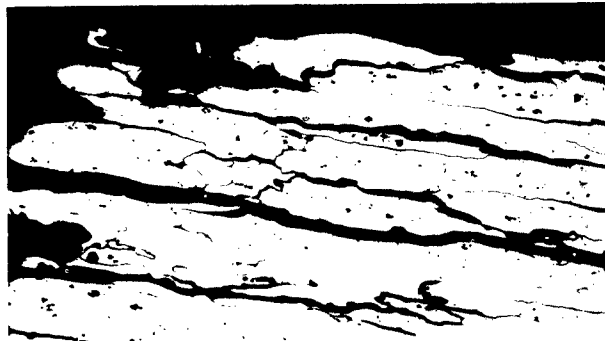
FIGURE 33.2. *Typical intercrystalline corrosion in one of the fittings. Unetched. $\times 100$.*
